# Aquatic Plant Control Research Program

Vol A-04-1

## Aquatic Vegetation Restoration in Drakes Creek, Tennessee

by Gary Owen Dick, R. Michael Smart, and Joe R. Snow

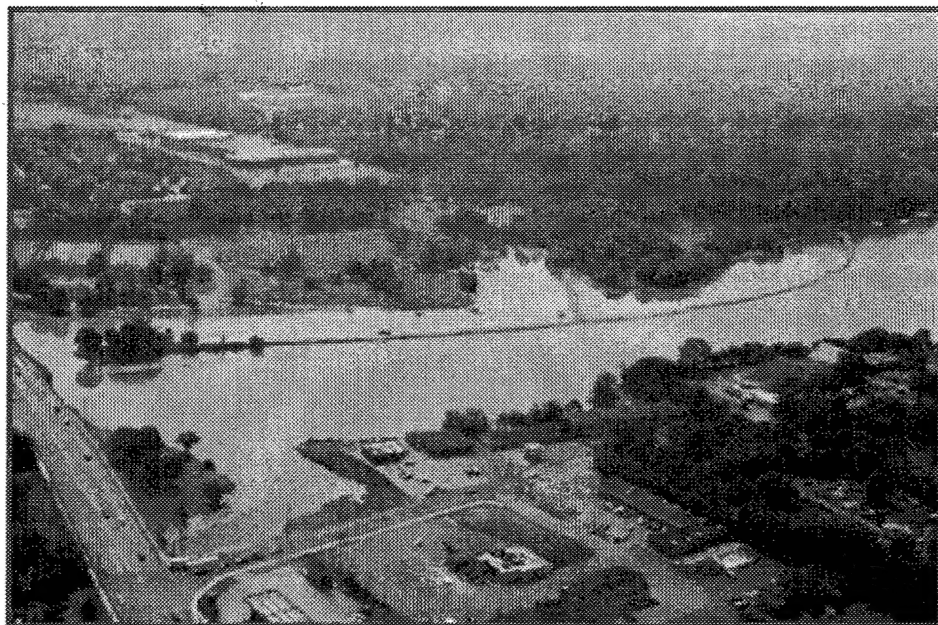
Figure 2. Aerial view of Drakes Creek restoration site (Phase 1)

The Lewisville Aquatic Ecosystem Research Facility (LAERF), U.S. Army Engineer Research and Development Center (ERDC), participated in Phase 1 of this project, employing techniques developed for establishing native aquatic plants in man-made reservoirs. In Phase 1, geo-tubes were filled with sediments dredged from approximately 17 acres of degraded (silted-in) aquatic habitat. The geo-tubes were installed to partially isolate a portion of the creek adjacent to Memorial Park from the main channel, thereby reducing silt deposition (Figure 2).
